# **Processing Plant Enters the Pipeline World**

**A Case Study of a Chemically Welded Anomaly Repair**

**By Randy Vaughn**  
**R&F Pipecon Resources**

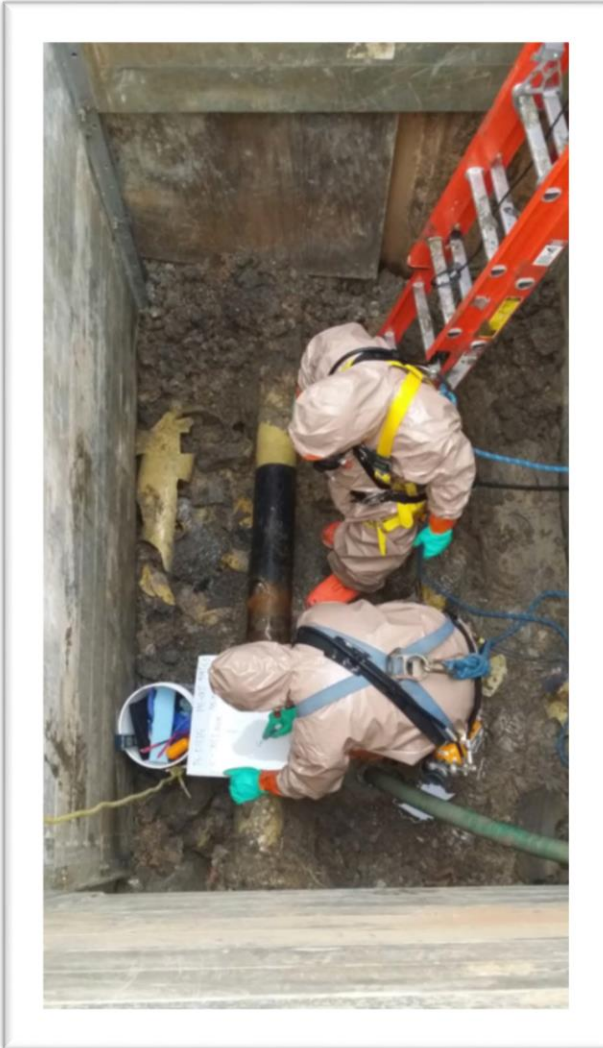
*The leak was located in a very congested pipeline corridor, just north of the PTRA railroad.*

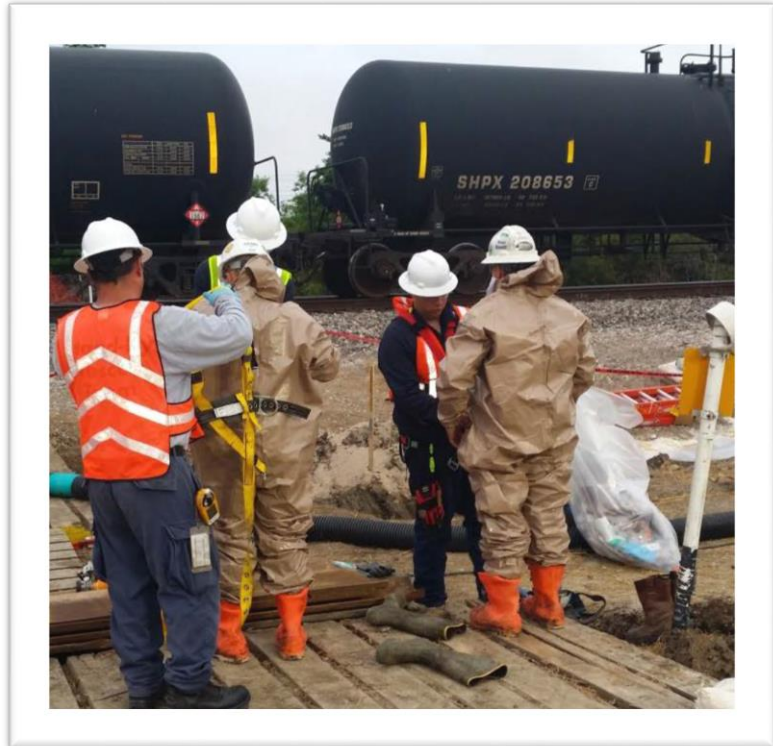
*Contract personnel preparing to enter the excavation and make necessary repairs.*

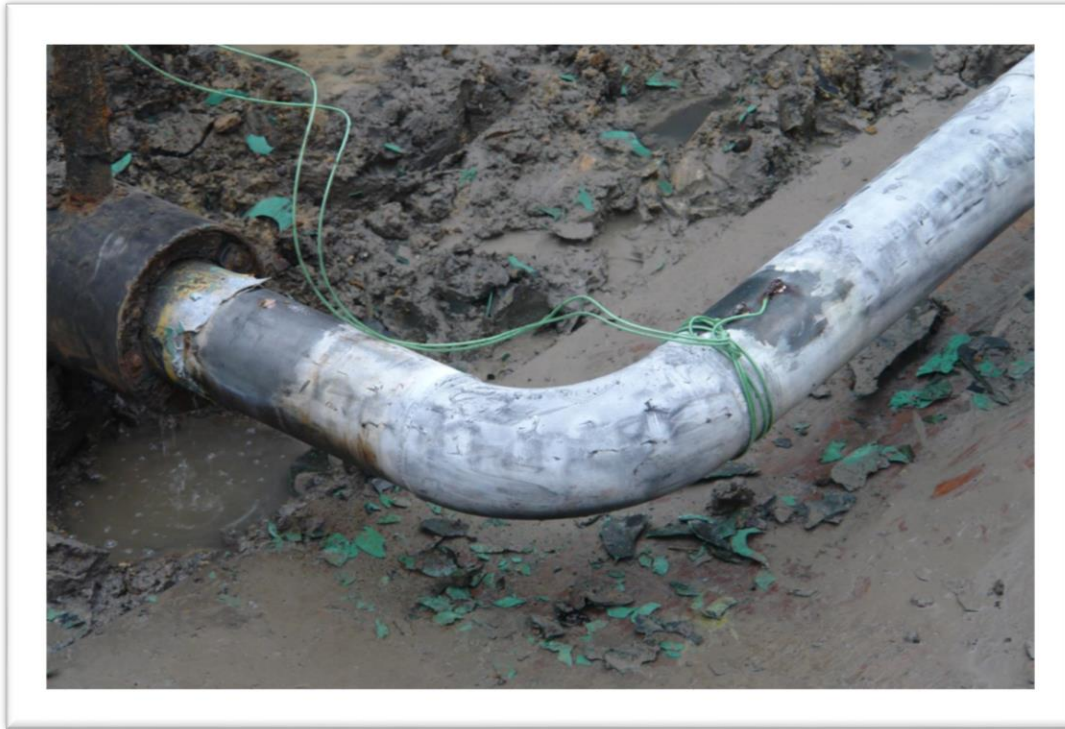
*South side of the PTRA cased crossing.*

All indications are that the vent pipes were installed on the casing pipe, but the casing vent holes were either not made, or they were made too small to accommodate pumping wax through them. This cased crossing will be monitored for the next year, and should indications of an electrolytic short becomes apparent between the carrier pipe and casing, the cased crossing should be replaced or have the casing ends expose again, and complete the waxing process.

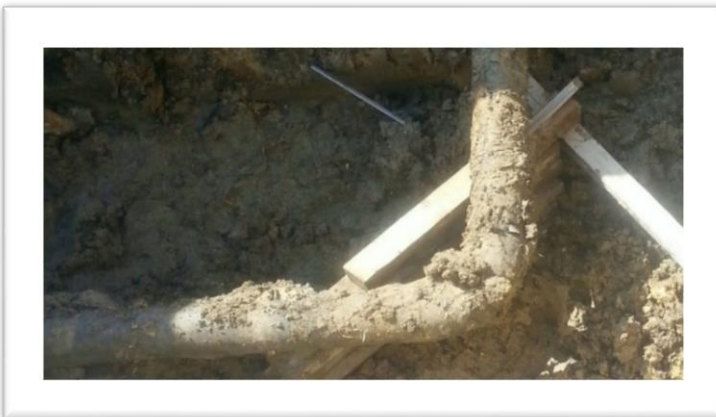
*This looked to be a possible tie-in weld that was mechanically forced into place in order to actually make the tie-in.*

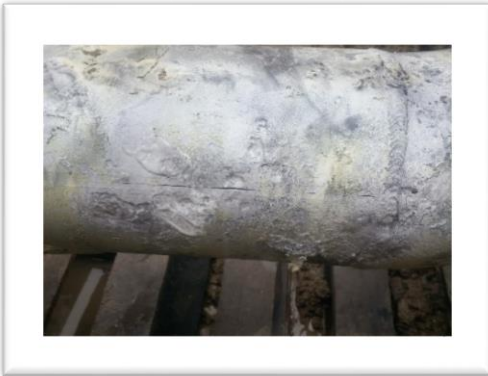
*Once the pipe surface area was cleaned, it became apparent just how much mechanical damage was done to the pipe. Also a crack in the ERW longitudinal seam weld of the pipe becomes very apparent.*

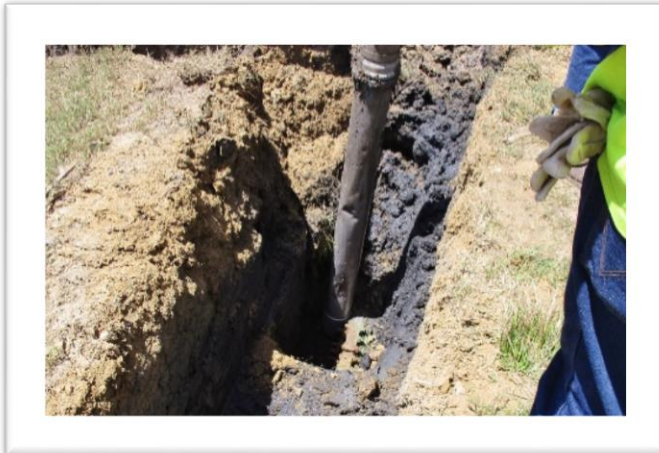
*The exposure of 2 leak clamps was found at excavation "D". Hydro-Vac was used for most of the excavation process.*

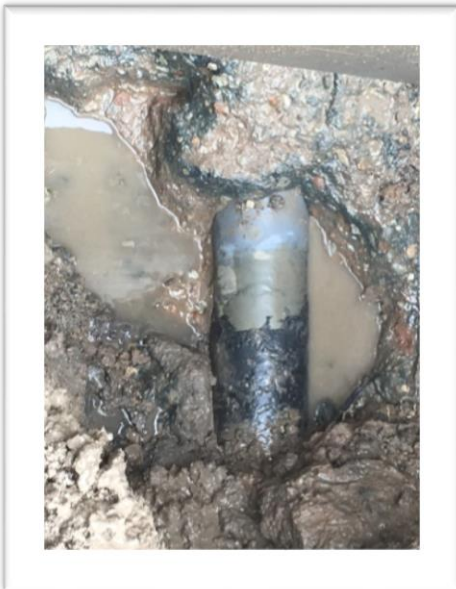
Concrete was poured over, and around the repair making it difficult to get to the repair itself. It was decided that attempts to break up the concrete should not be done in fear of damaging the repair. Any bare pipe found during this excavation was coated and the excavation was backfilled.

*Oops! Not exactly what was not expected at the exploratory Excavation "A". Someone poured concrete. Recoated what pipe was exposed as possible and backfilled.*

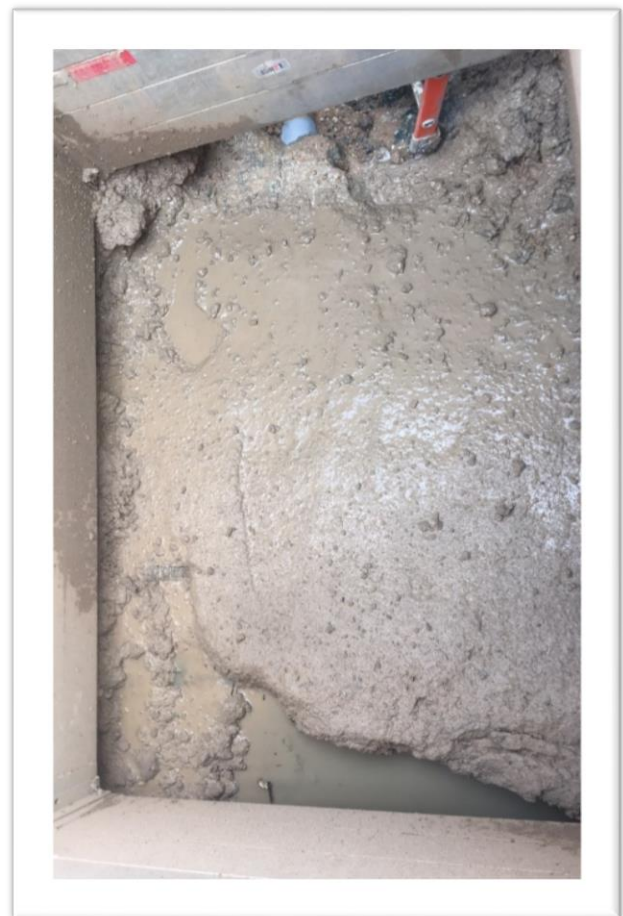
*Attempts to remove concrete were not made for fear of damage to the repair.*

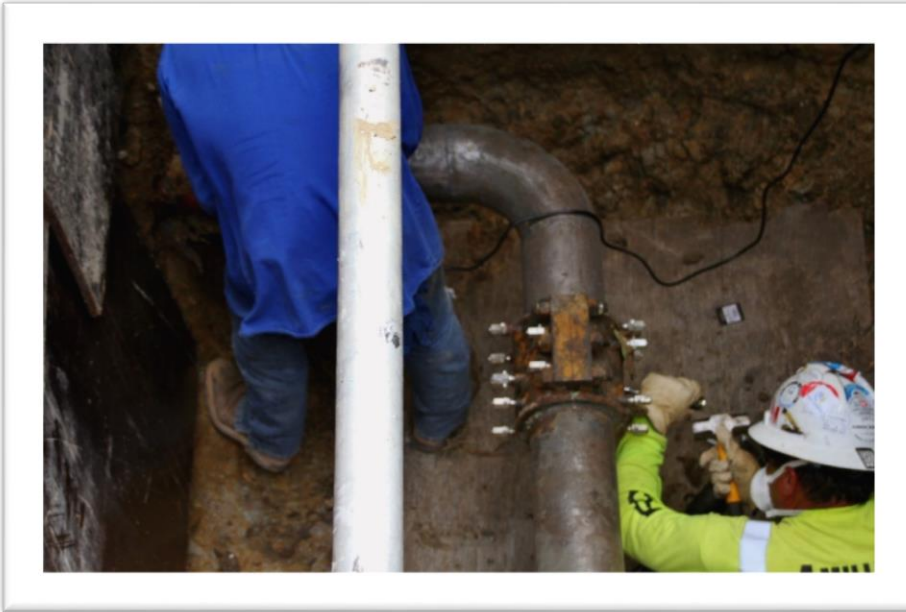
*Leak clamp removal of Excavation B. While looking for good coating to determine the re-coat area, once the sleeve is installed.*

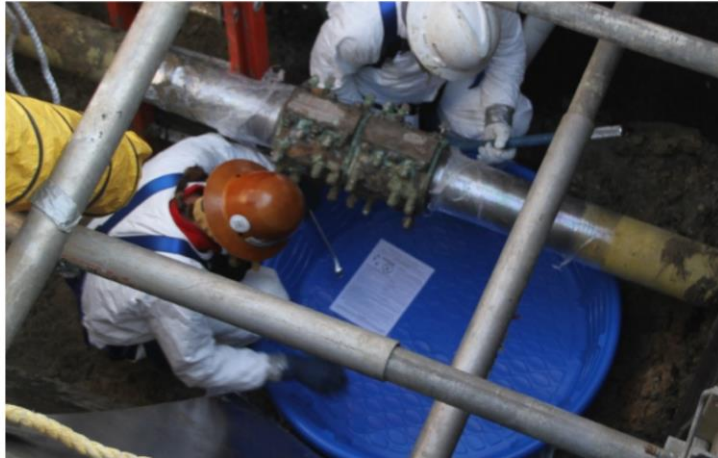
*The 2 clamps are located and made ready for removal.*

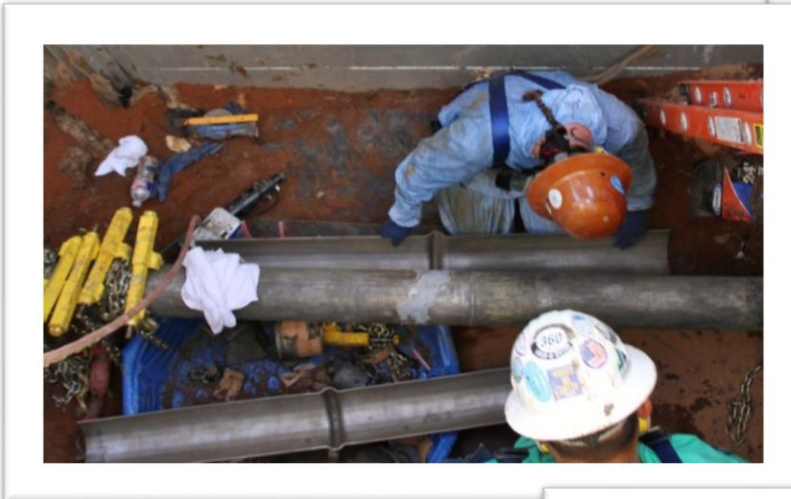
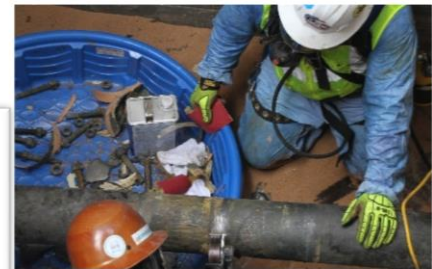
*It would seem that just after a year these clamps were ready to be replaced.*

Concerning the leak clamps, it appears the coating was not applied correctly, or perhaps the surface area for the clamps was not thoroughly prepared. At any rate, the clamps were not going to hold-up much longer. The active corrosion was obviously due the interaction of dissimilar metals used to manufacture the clamps. It was fortuitous in this case that the processing plant made the decision to change out the clamps.

*Once the clamps are removed, a trial fit of the sleeves is performed.*
