# **Processing Plant Enters the Pipeline World**

**A Case Study of a Chemically Welded Anomaly Repair**

**By Randy Vaughn**  
**R&F Pipecon Resources**

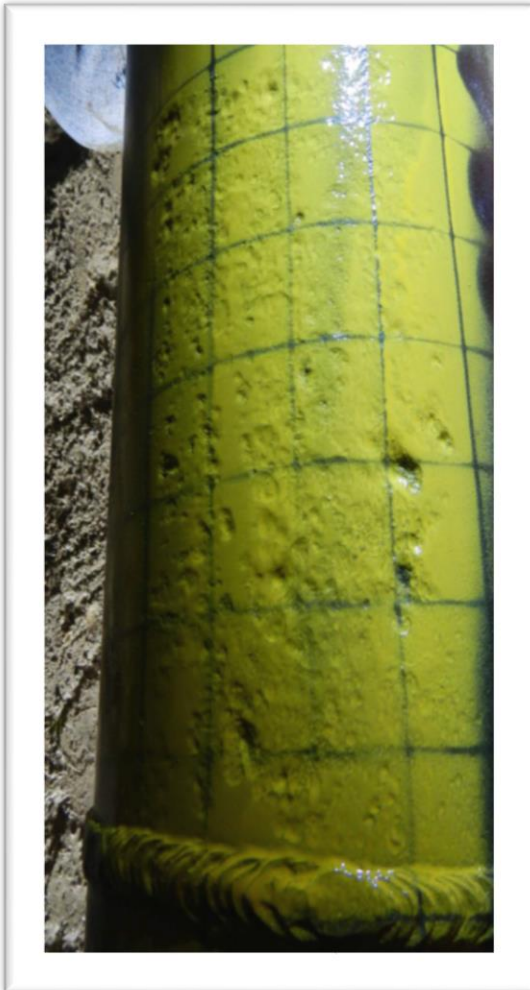
Through a root-cause analysis process, several common integrity threats believed to be inherent of older pipelines were also eliminated. The pipeline's electrical resistance welded (ERW) longitudinal seam was examined, and all indications were that the seam was intact and had no corrosion due to the welding process during the manufacturing of the line pipe.

No SCC was found in any of the exposed pipe. Dye penetrant nondestructive examination (NDE) process was used to address these SCC determinations. And the factory applied polyethylene extruded coating that was exposed showed no indications of any CP shielding issues. The presence of microbiologically induced corrosion (MIC) as a threat was also proven not to exist.

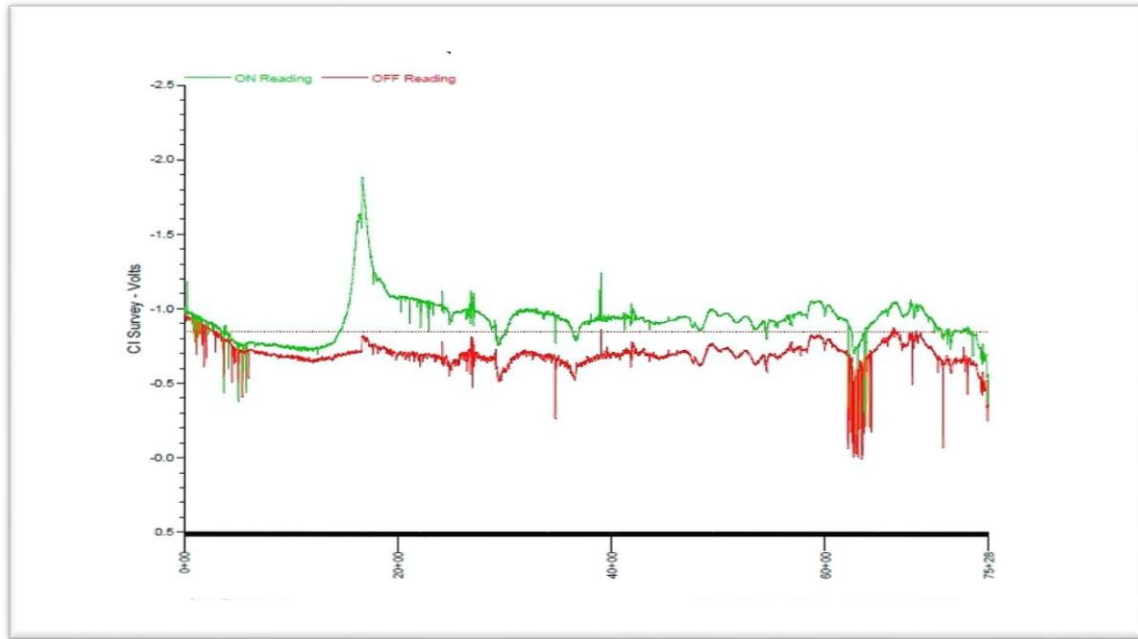
*Close Interval Survey results with the new impressed current CP system in operation.*

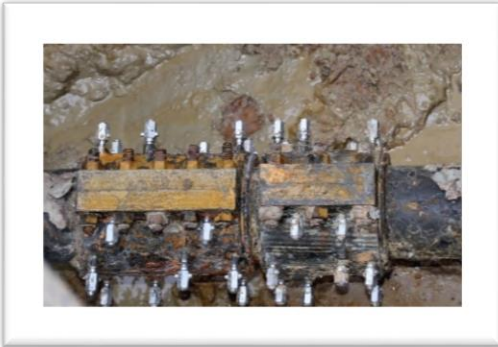
## Excavation H

In all, there were 5 excavations made and 5 Composi-Sleeve™ installed. Excavation H was one that merits some discussion, in that it consisted of 2 leaks – one on either side of a girth weld. The 2 clamps used in the earlier repair were removed and replaced by 1 Composi-Sleeve™ designed to accommodate the raised girth weld. Each Composi-Sleeve™ is designed and fabricated using strict specifications to conform for a tight fit and ensure both strength and durability, such as the case of Excavation H.

*It would seem that just after a year these clamps were ready to be replaced.*
